Manhole Inspection Summary

Manhole # S39S__021MH

Insp Date: **3/13/08 7:44 AM**

Location Address: **611 harvey st**

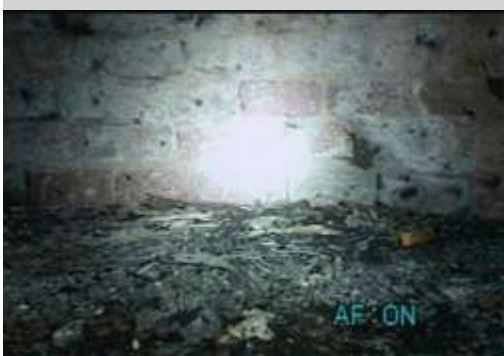
bench debris

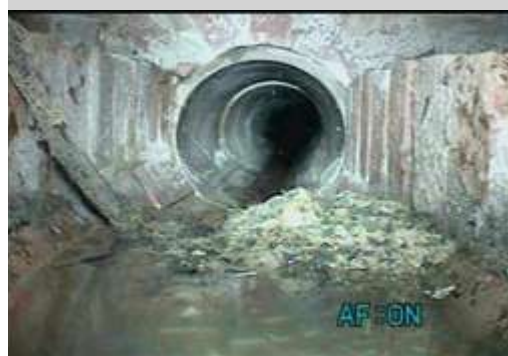
Defect 4

Condition: ☐ Sound ☐ Cracked ☐ Root Intrusion ☐ Deteriorated ☐ Leaks ☒ **Debris**

channel debris

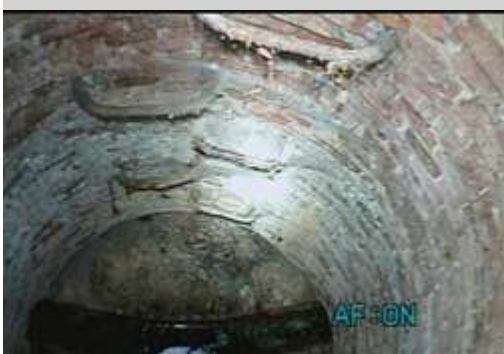
Defect 2

Steps Count: **5** Missing: **0** ☒ **Corroded**

corroded steps

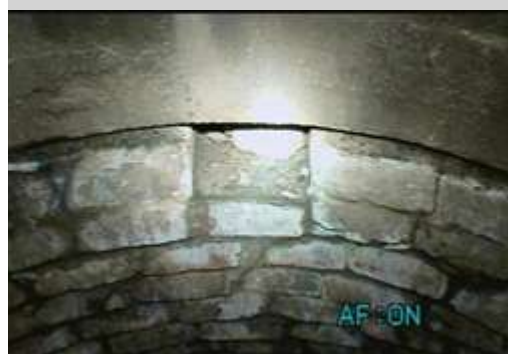
Defect 1

Frame Offset: **1** (in.) Condition: ☒ Sound ☐ Cracked ☐ Leaks

Condition: ☐ Sound ☐ Cracked ☐ Root Intrusion ☒ **Loose Brick** ☐ Deteriorated

chimney loose brick/offset

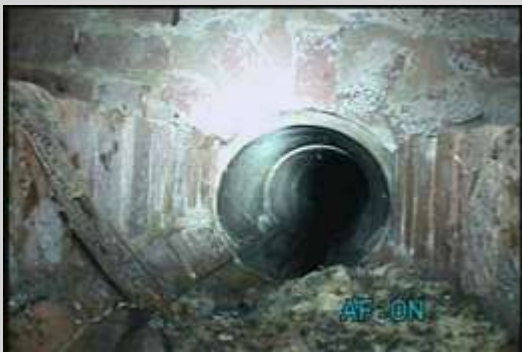
12 O'Clock Outflow

8 in. Circular Gravity Sewer
Pipe Out @ 12 O'Clock

Invert Depth: **8.70** (ft.) Flow Characteristics: **Slow**

Deposits: ☒ None ☐ Mud ☐ Sludge ☐ Debris ☐ Grease

Infiltration: **None** Pipe Seal Cond: **Unknown**

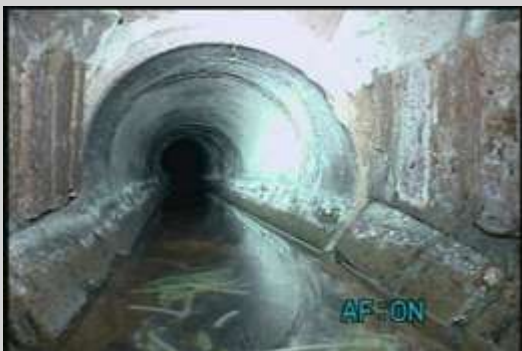
5 O'Clock Inflow

8 in. Circular Gravity Sewer
Pipe In @ 5 O'Clock

Invert Depth: **8.60** (ft.) Flow Characteristics: **Slow**

Deposits: ☒ None ☐ Mud ☐ Sludge ☐ Debris ☐ Grease

Infiltration: **None** Pipe Seal Cond: **Unknown**
